(SAMPLE) RAPID AUDIT CELL TOWER REPORT

ABC Company, Inc. Cell Tower (EXAMPLE) RAPID AUDIT Inspection Report

Example Project Overview

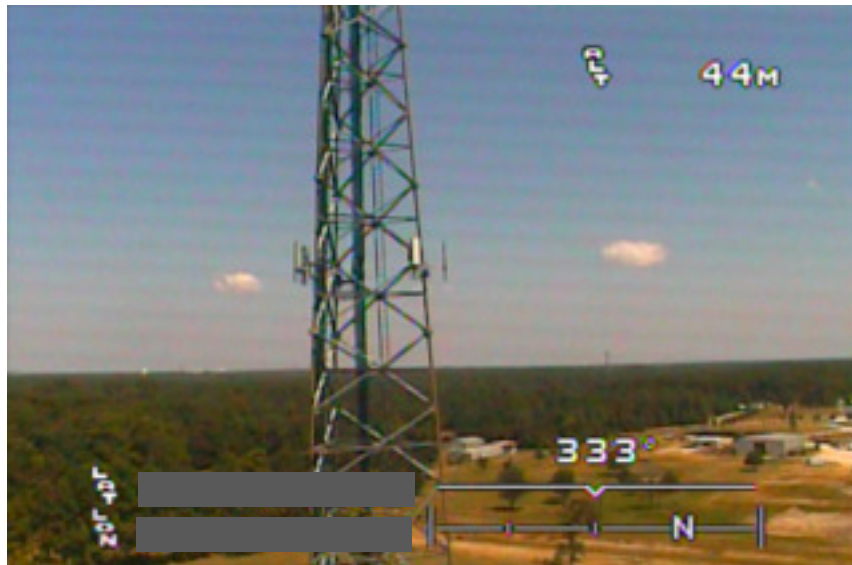
45 Meter Level Overview

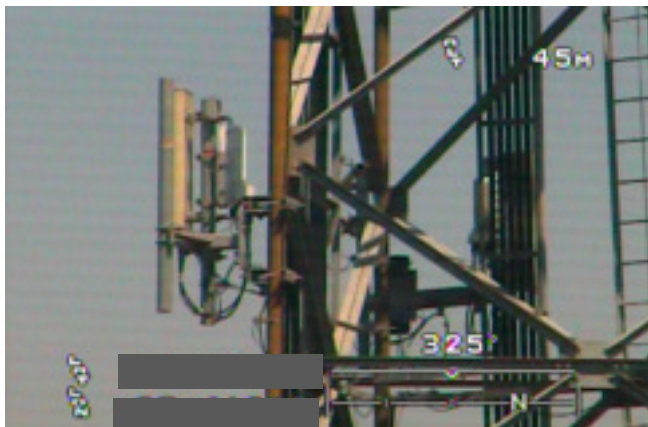
Antenna Inspection

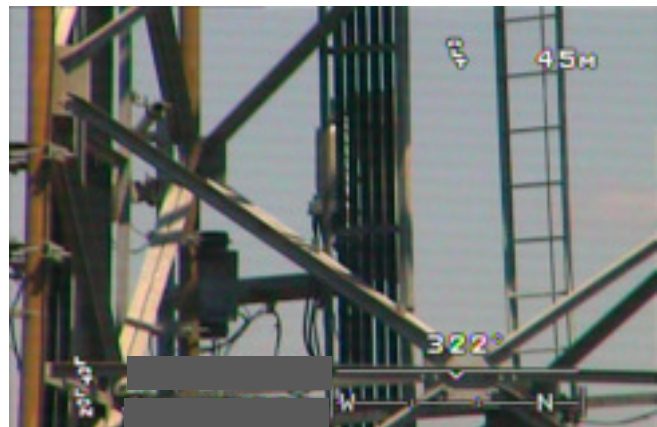
Interior Cabling Inspection

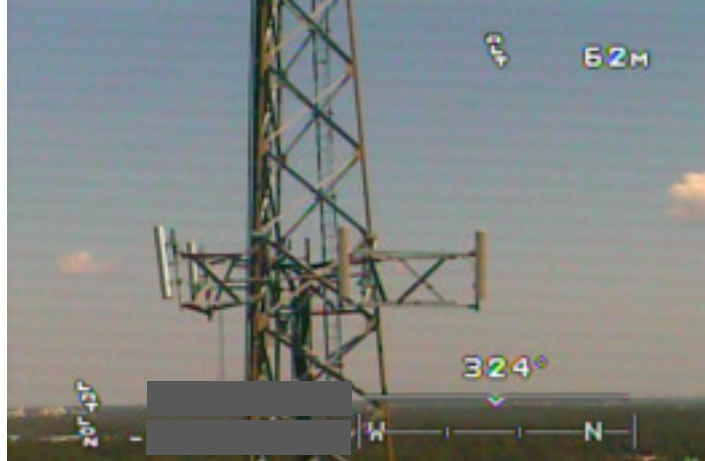
65 Meter Level Overview

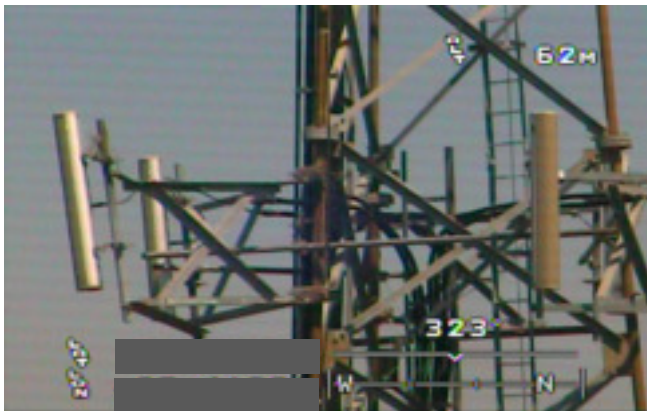
Antenna Inspection

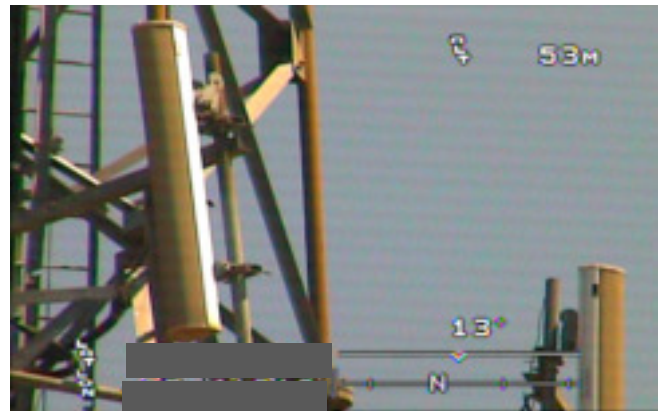
Antenna Inspection

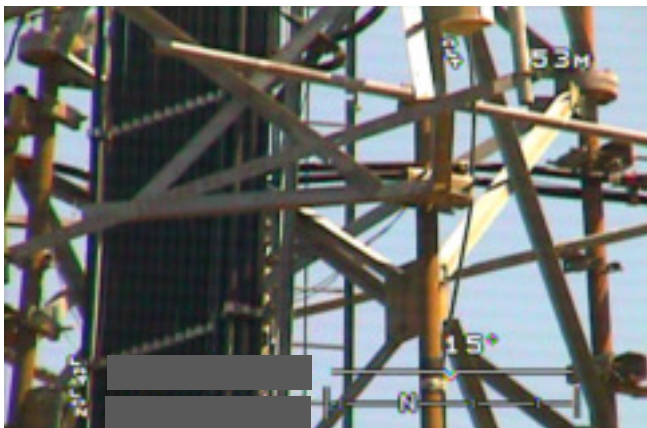
Interior Cabling Inspection

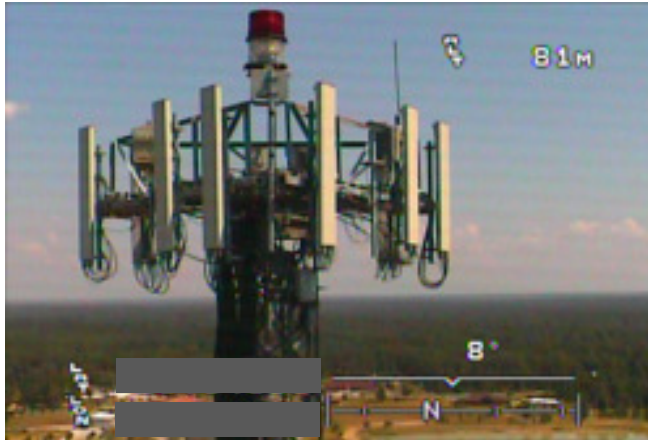
85 Meter Level Overview

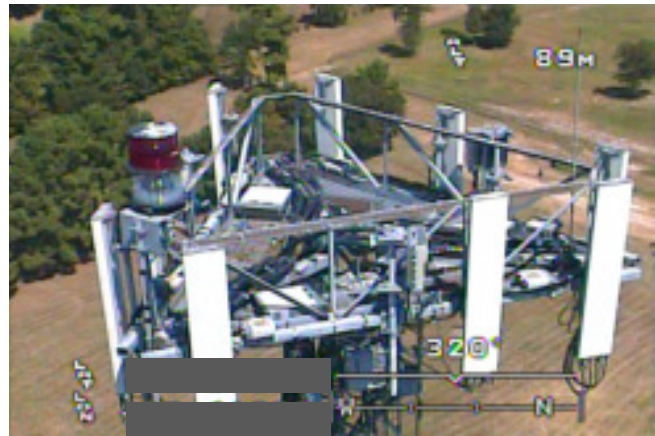
85 Meter Level Overview

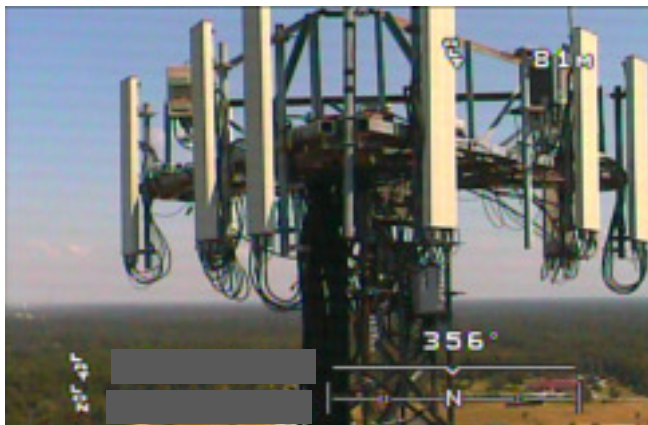
Antenna Inspection

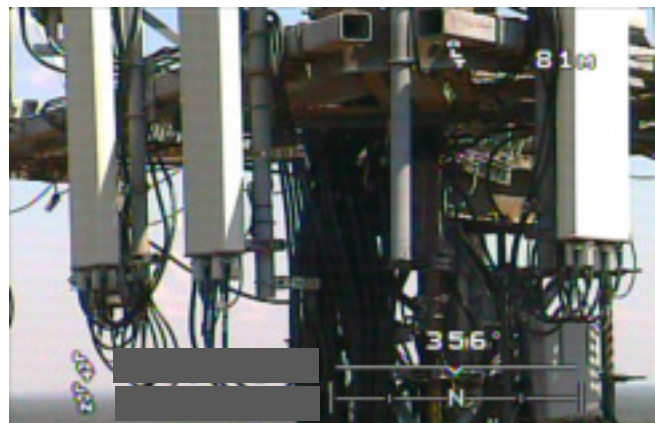
Antenna Cabling Inspection

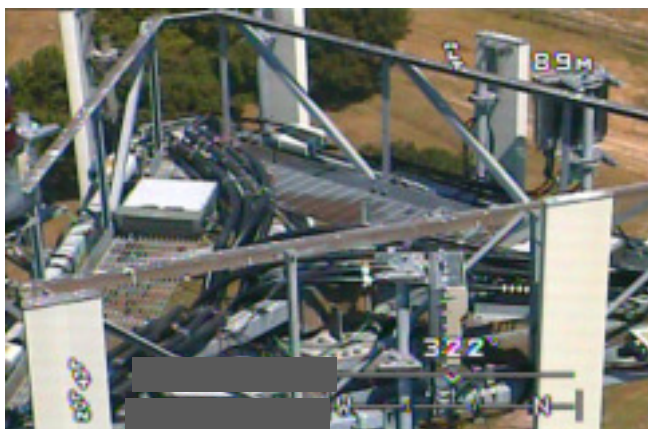
Top Platform Equipment Inspection

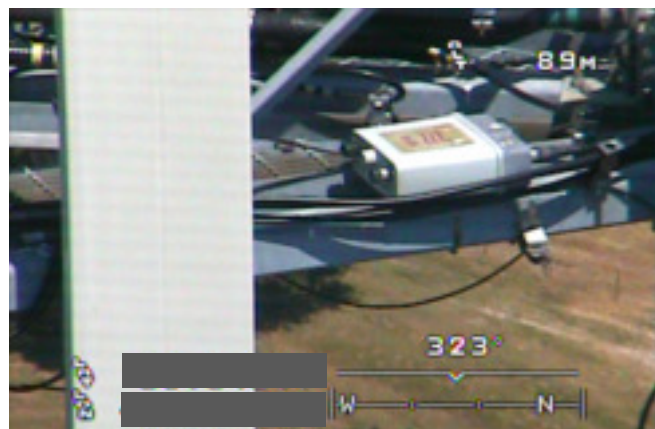
Top Platform Equipment Inspection
